Manhole Inspection Summary

Manhole # S31S1_018MH

Insp Date: **2/15/08 9:39 AM**

Location Address: **1349 Spelman Road**

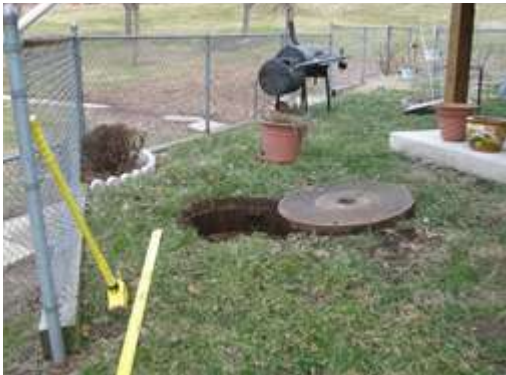
Location View

Spelman Rd. (backyard)

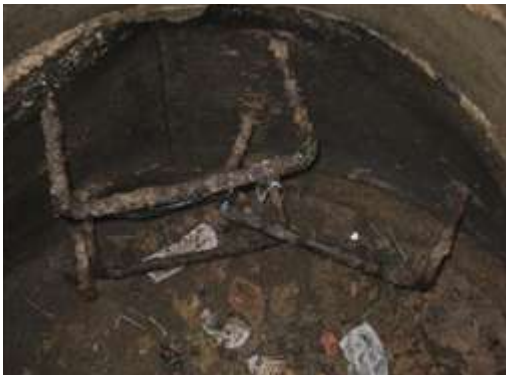
Steps Count: **3** Missing: **0** ☐ Corroded

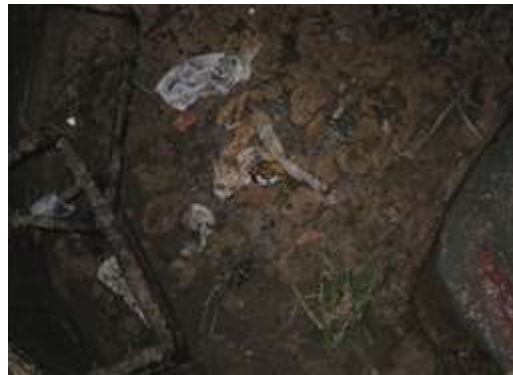
Defect 2

Condition: ☒ Sound ☐ Cracked ☐ Root Intrusion ☐ Deteriorated ☐ Leaks ☐ Debris

Bench

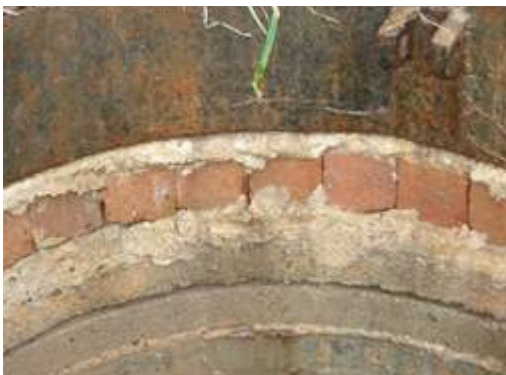
Defect 1

Infiltration: ☐ None ☐ Joint ☐ Cracks ☒ Mortar ☐ Roots ☐ Wall

Infiltration

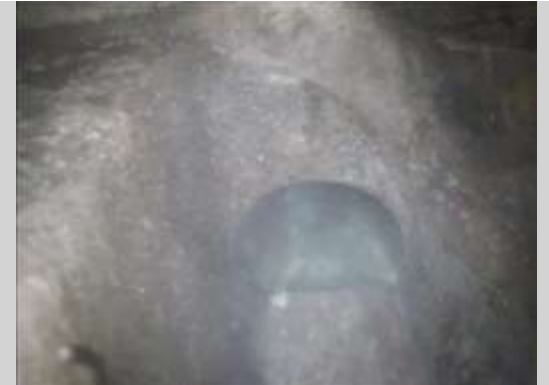
12 O'Clock Outflow

8 in. Circular Gravity Sewer
Pipe Out @ 12 O'Clock

Pipe Height: **8.4** (in.) Rod and Bar (Angled)
Pipe Material: **PVC** ☐ Pipe Lined
Invert Depth: **10.44** (ft.) Flow Characteristics: **Fast**
Deposits: ☒ None ☐ Mud ☐ Sludge ☐ Debris ☐ Grease
Silt Depth: (in.) Deposits Extent:
Infiltration: **None** Pipe Seal Cond: **Sound**

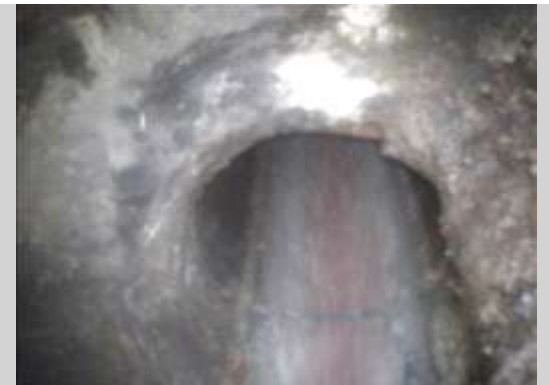
3 O'Clock Inflow

8 in. Circular Gravity Sewer
Pipe In @ 3 O'Clock

Pipe Height: **8.4** (in.) Rod and Bar (Angled)
Pipe Material: **Clay** ☐ Pipe Lined
Invert Depth: **9.79** (ft.) Flow Characteristics: **Fast**
Deposits: ☒ None ☐ Mud ☐ Sludge ☐ Debris ☐ Grease
Silt Depth: (in.) Deposits Extent:
Infiltration: **None** Pipe Seal Cond: **Sound**
